National  
Trust

Case Study

## Burst pipes

Flood water ingress  
due to burst pipes  
January 2011

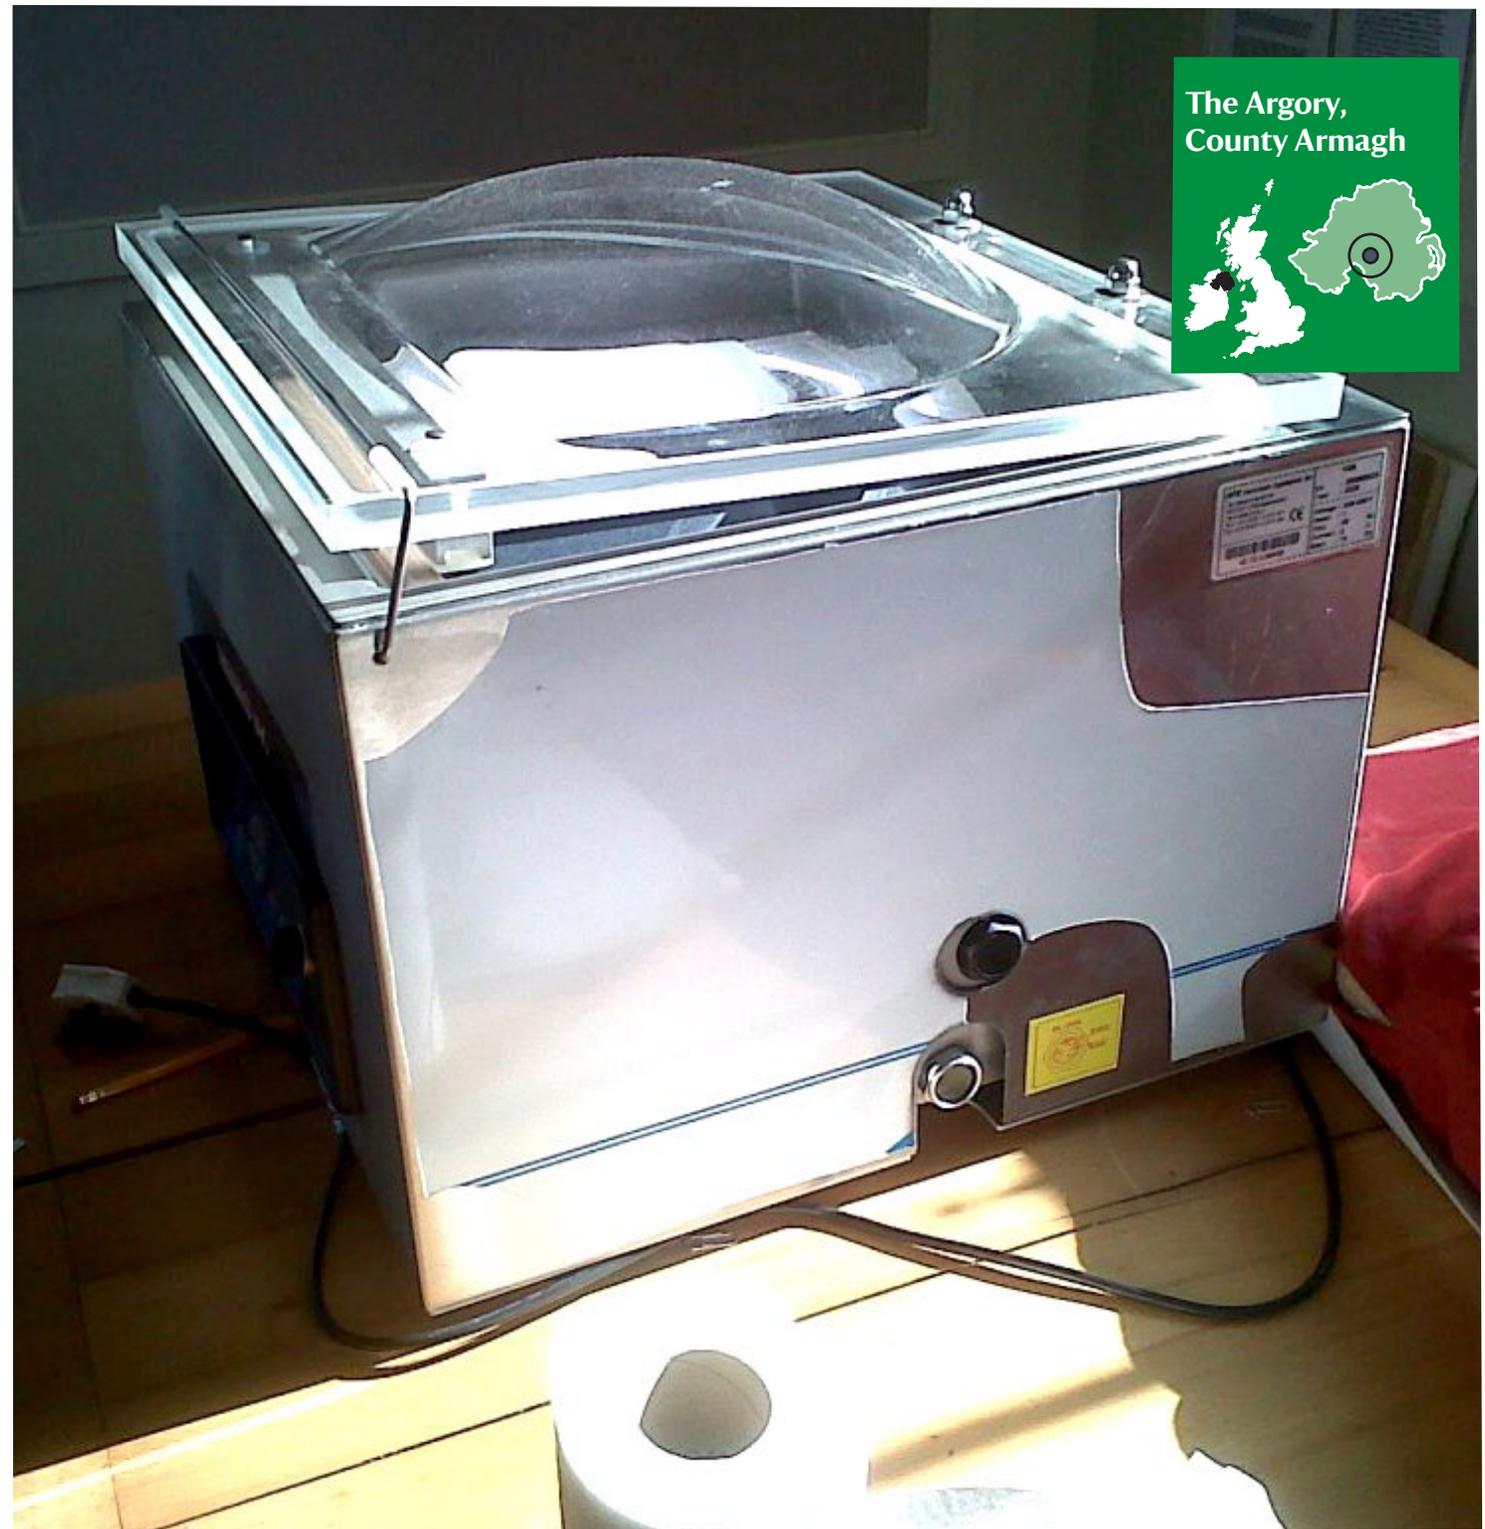
On the cover **The Archipress machine**: Drying out books

The Archipress was delivered by Castle Ward staff, and the very wet hardback books were isolated by vacuum packing. The rest were slowly dried out. The property was unable, however, to source much needed de-humidifiers, fans etc, due to the holiday period. Northern Ireland had also experienced the highest incidence of flooding in commercial and private properties, meaning that dehumidifiers were extremely difficult to source.

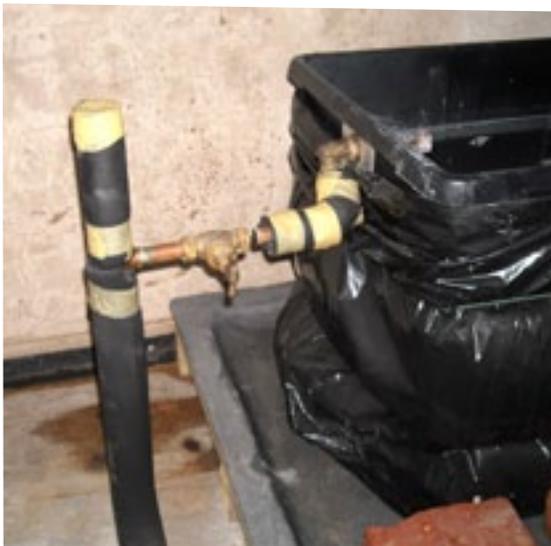
**Bottom left The source of the flood**

A burst pipe in the attics had flooded directly into the Archive room and Tommy's bedroom on the first floor. It continued down into the Study and right through to the underlying basement. The flood was caused by a burst pipe in the Garrets, where a mains water pipe feeding the toilets within the Mansion had burst in the thaw. A substantial amount of water fell in a short period. It took three days to sort and treat all the affected objects (directing people, setting up work stations, separating dry, damp and wet objects) before an assessment could be made of the damage.

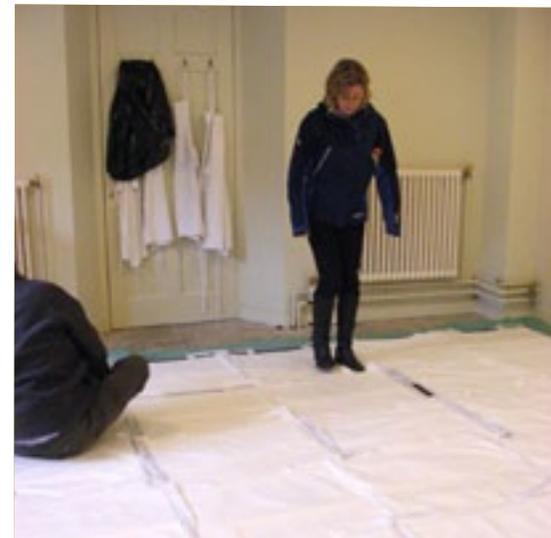
Bottom right **Using absorbent materials on the carpets**

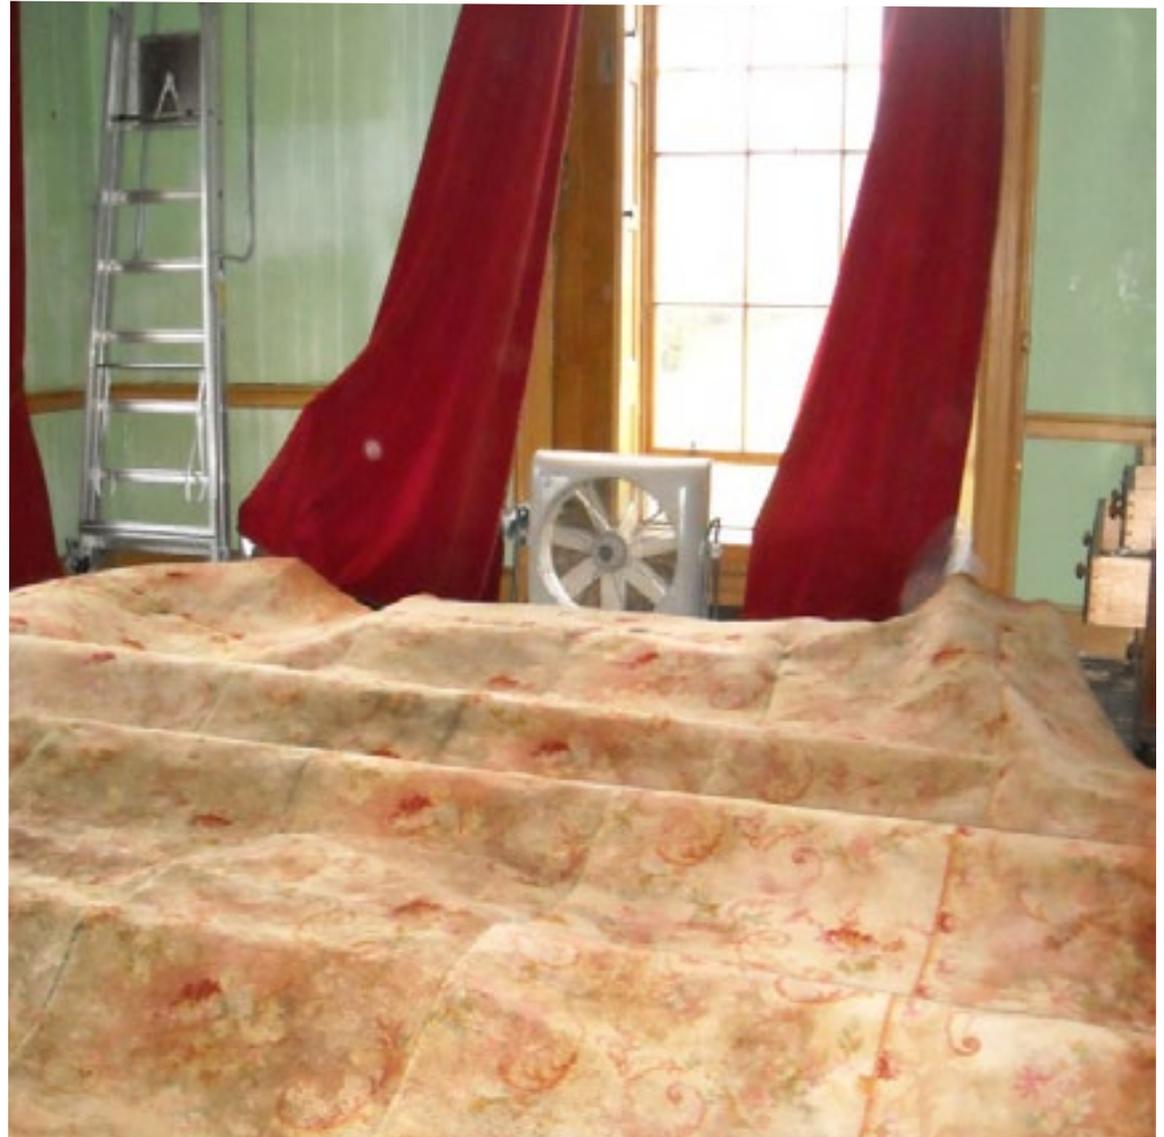
Above **The Study**: Underfelt removed, cold fans installed and the carpets propped on crates and pipes
